○○○○○○○
MAC-PANEL

Operation Description for
561344

561344-CU

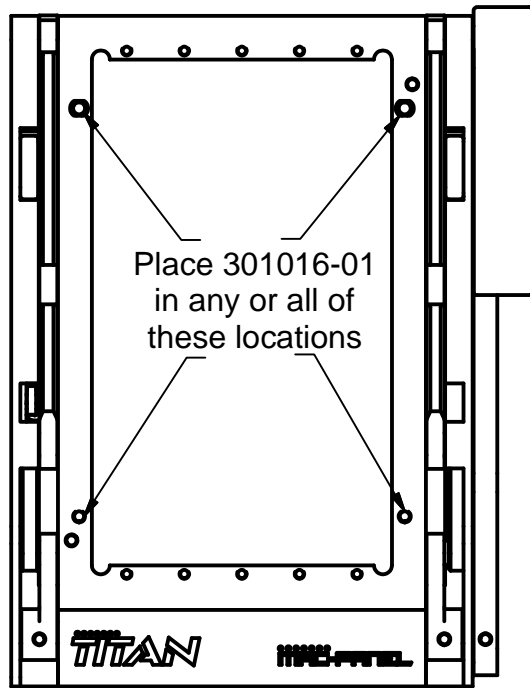
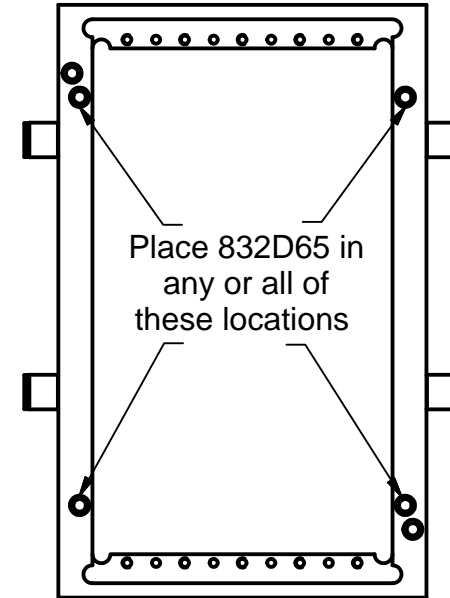
Receiver

ITA

301016-01

832D65

The principle is wherever an 832D65 is located in the ITA a 301016-01 can not be located in the Receiver hole aligning with the same hole so ensuring only the correct ITA will engage with the Receiver.
